SMOKE TESTING OBSERVATION SUMMARY

Western Run Pilot Project - Baltimore Maryland

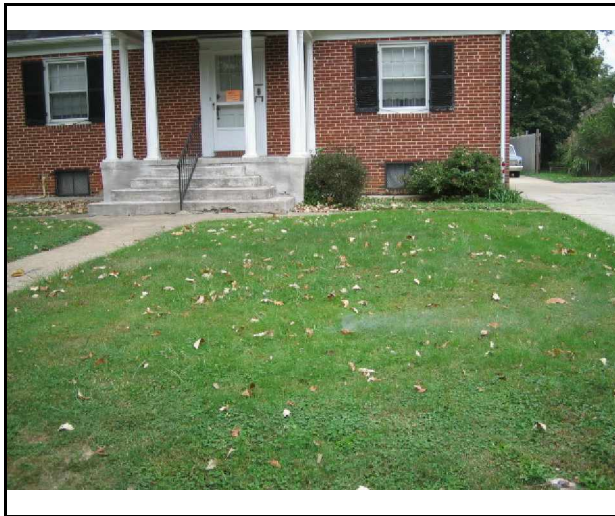
Photo No: 551

Unique Test ID	281	Date:	10/13/2004	MeterBasin:	01_WR29
Observer ID:	B	Crew:	T-2	Dye Test Recommended:	N
Defect No:	9	Setup No:	4	Priority CCTV:

House Number	3504	Street Prefix:		Street Name:	Olympia	Street Type:	AVE
Source Type:	04= Cleanout	Location:	7=Yard-Front	Severity:	4=Major		
Sector:	2=Private	Drainage Area:	0				
Comments:

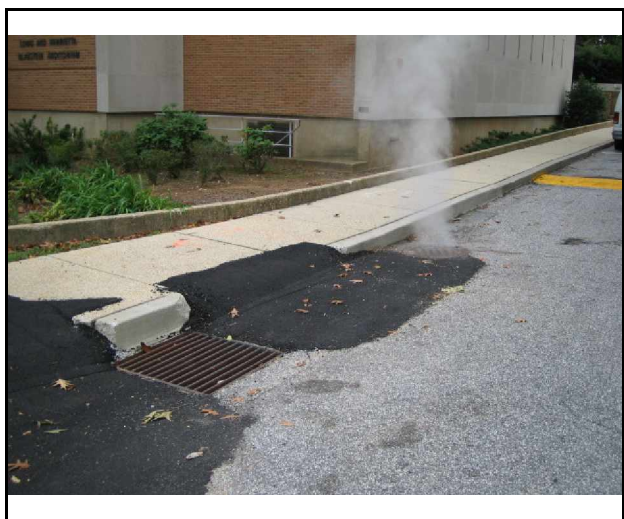
Photo No: 18

Unique Test ID	282	Date:	10/13/2004	MeterBasin:	01_WR29
Observer ID:	A	Crew:	T-3	Dye Test Recommended:	N
Defect No:	1	Setup No:	1	Priority CCTV:

House Number	7310	Street Prefix:		Street Name:	Park Heights	Street Type:	AVE
Source Type:	18= Other	Location:	2=Paved Asphalt	Severity:	4=Major		
Sector:	1=Public	Drainage Area:	1500				
Comments:	MH U-01520693A @ temple - stormdrain MH cover on San.MH

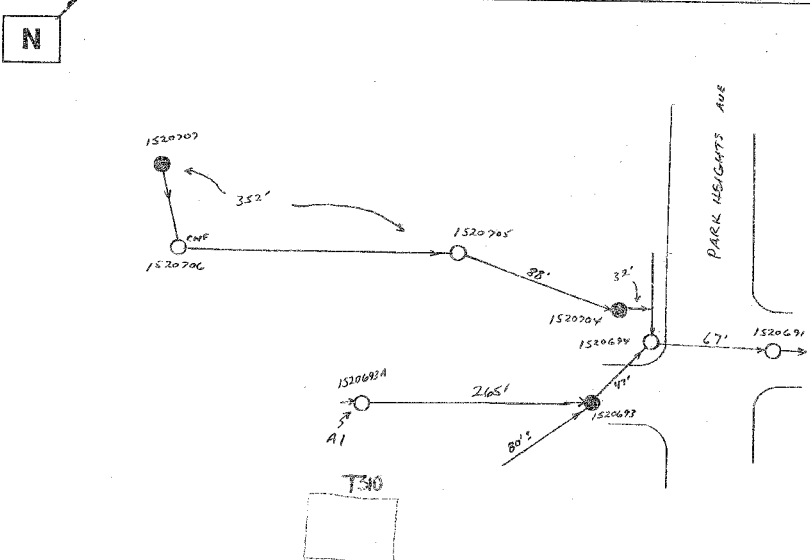
282

TEST LOCATION			
Project: WRPA	Sewershed: Jones Falls	Date: <u>10-13-04</u>	Start Time: <u>0800</u>
Crew: <u>T3</u>	Street Location: <u>PARK HEIGHTS AV 7300 - 7396</u>	<u>(DARK WILL 168)</u>	
US MH: <u>1520707</u>	DS MH: <u>1520704</u>	Number of Segments: <u>7</u>	Test Length: <u>931'</u>
Plugged US: <u>Y</u> <u>N</u>	Plugged DS: <u>Y</u> <u>N</u>	# of Blowers <u>1 2 3</u>	Ground: <u>Dry</u> Moderate Wet
Plugs Removed? <u>Y</u> <u>N</u>	Recorder: <u>SAH</u>	Comments: <u>ONE -> 1520706 / LINE TO 1520694 NOT ON MAP</u>

NO SMOKE WAS GETTING TO THE U.S. MH. 1520707 LINE WAS BLOWN FROM 1520704 & NO SMOKE WAS GETTING TO 1520704 FROM 1520707, MAY BE A BLOCKAGE IN BETWEEN.

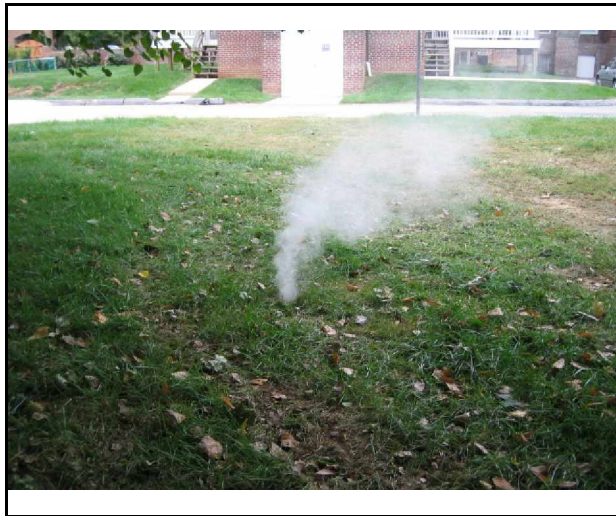
Photo No: 17

Unique Test ID	283	Date:	10/13/2004	MeterBasin:	
Observer ID:	A	Crew:	T-3	Dye Test Recommended:	N
Defect No:	1	Setup No:	2	Priority CCTV:	
House Number	7301	Street Prefix:	Street Name:	Street Type:	
			Park Heights	AVE	
Source Type:	04= Cleanout	Location:	8=Yard-Back	Severity:	4=Major
Sector:	2=Private	Drainage Area:	50		
Comments:	behind address

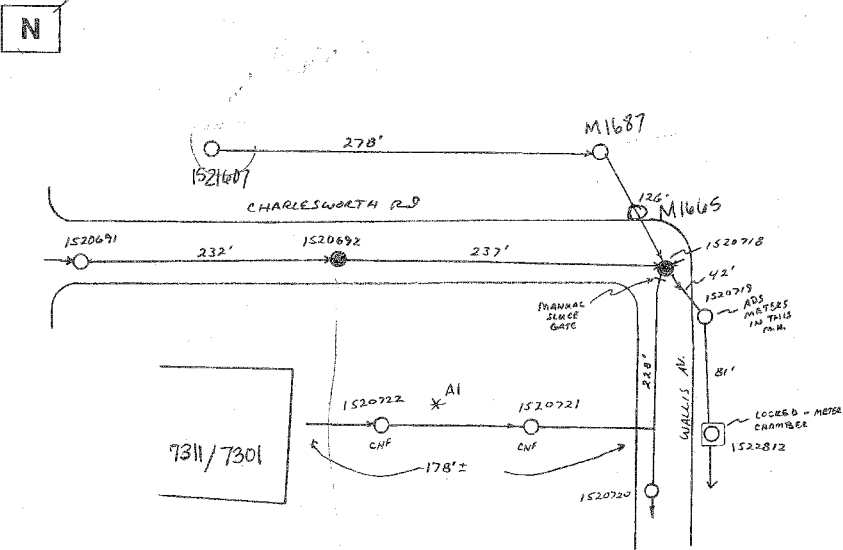
Sketch No: 283

TEST LOCATION			
Project: WRPA	Sewershed: Jones Falls	Date: 10-13-04	Start Time: 0915
Crew: T3	Street Location: CHARLESWORTH RD.		
US MH: 1520691	DS MH: 1520718	Number of Segments:	Test Length: 1402
Plugged US: Y <input checked="" type="checkbox"/> N	Plugged DS: Y <input checked="" type="checkbox"/> N	# of Blowers: 1 @ 3	Ground: <input checked="" type="checkbox"/> Dry Moderate Wet
Plugs Removed? Y N	Recorder: <i>AM</i>	Comments: C.N.F. 1520722 & 1520721

Too lg. to plug

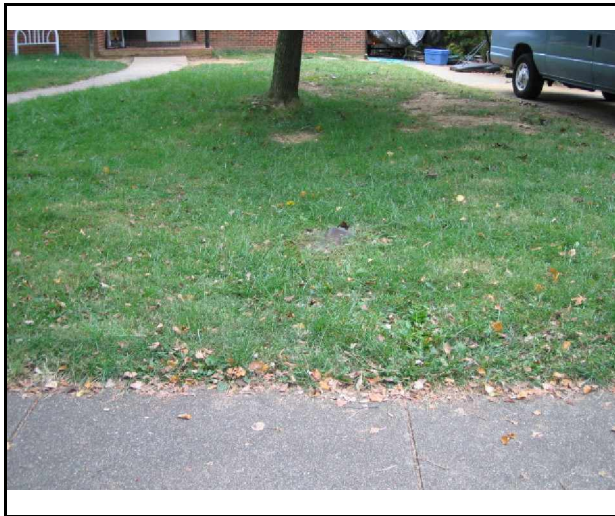
Photo No: 19

Unique Test ID	285	Date:	10/13/2004	MeterBasin:	01_WR29
Observer ID:	A	Crew:	T-3	Dye Test Recommended:	N
Defect No:	1	Setup No:	4	Priority CCTV:

House Number	3405	Street Prefix:		Street Name:	Shelburne	Street Type:	ROAD
Source Type:	04= Cleanout	Location:	7=Yard-Front	Severity:	3=Moderate		
Sector:	2=Private	Drainage Area:	0				
Comments:

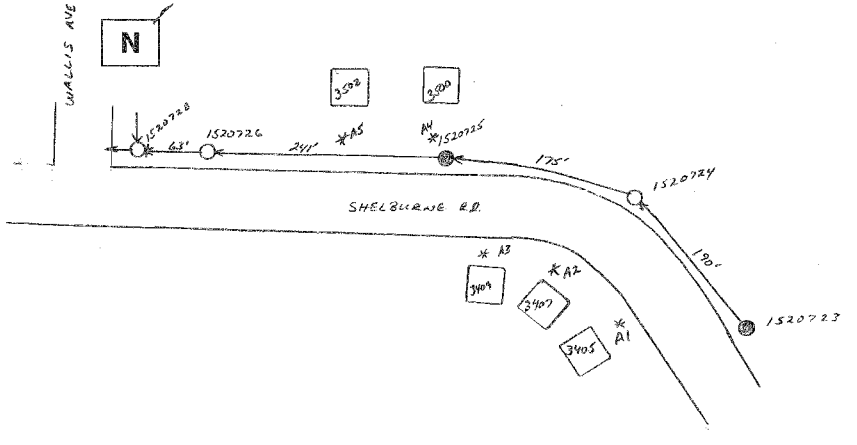
285

TEST LOCATION			
Project: WRPA	Sewershed: Jones Falls	Date: 10-13-04	Start Time: 1350
Crew: T3	Street Location: SHELburne RD		
US MH: 1520728	DS MH: 1520728	Number of Segments:	Test Length: 669'
Plugged US: Y <input checked="" type="checkbox"/> N	Plugged DS: Y <input checked="" type="checkbox"/> N	# of Blowers: 1 2 3	Ground: <input checked="" type="checkbox"/> Dry Moderate Wet
Plugs Removed? Y <input checked="" type="checkbox"/> N	Recorder: [Signature]	Comments: SMOKE LAD D HARD TIME GETTING BETWEEN 1520728 & 724

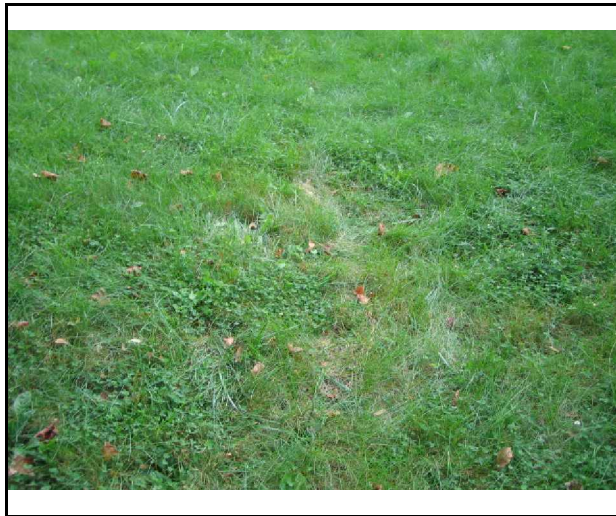
Photo No: 20

Unique Test ID	285	Date:	10/13/2004	MeterBasin:	01_WR29
Observer ID:	A	Crew:	T-3	Dye Test Recommended:	N
Defect No:	2	Setup No:	4	Priority CCTV:

House Number	Street Prefix:	Street Name:	Street Type:
3407		Shelburne	ROAD

Source Type:	04= Cleanout	Location:	7=Yard-Front	Severity:	3=Moderate
Sector:	2=Private	Drainage Area:	100

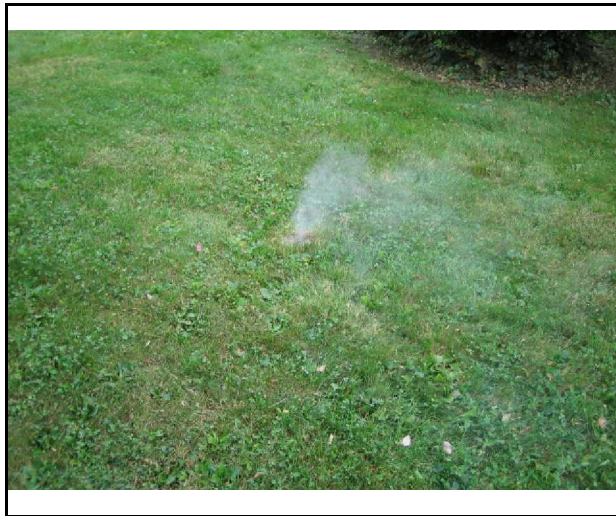
Photo No: 21

Unique Test ID	285	Date:	10/13/2004	MeterBasin:	01_WR29
Observer ID:	A	Crew:	T-3	Dye Test Recommended:	N
Defect No:	3	Setup No:	4	Priority CCTV:

House Number	Street Prefix:	Street Name:	Street Type:
3409		Shelburne	ROAD

Source Type:	04= Cleanout	Location:	7=Yard-Front	Severity:	3=Moderate
Sector:	2=Private	Drainage Area:	0

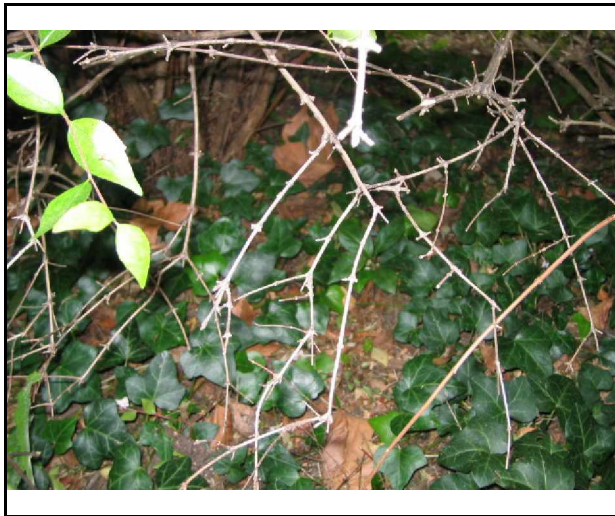
Photo No: 22

Unique Test ID	285	Date:	10/13/2004	MeterBasin:	01_WR29
Observer ID:	A	Crew:	T-3	Dye Test Recommended:	N
Defect No:	4	Setup No:	4	Priority CCTV:

House Number	Street Prefix:	Street Name:	Street Type:
3500		Shelburne	ROAD

Source Type:	04= Cleanout	Location:	7=Yard-Front	Severity:	3=Moderate
Sector:	2=Private	Drainage Area:	0

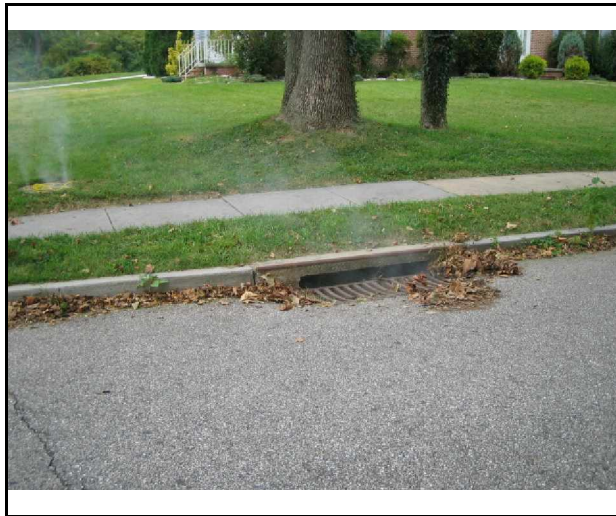
Unique Test ID	286	Date:	10/13/2004	MeterBasin:	01_WR29
Observer ID:	A	Crew:	T-3	Dye Test Recommended:	Y
Defect No:	1	Setup No:	5	Priority CCTV:

House Number	3506	Street Prefix:		Street Name:	Shelburne	Street Type:	ROAD
Source Type:	14= Catch Basin	Location:	2=Paved Asphalt	Severity:	4=Major		
Sector:	1=Public	Drainage Area:	5000				
Comments:	north corner

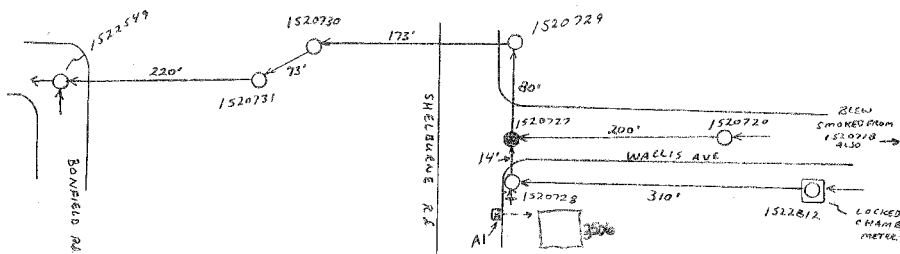
* SMOKE FROM A EARLIER SET UP WAS BLOWN DOWN FROM M.H. 1520728 ALSO

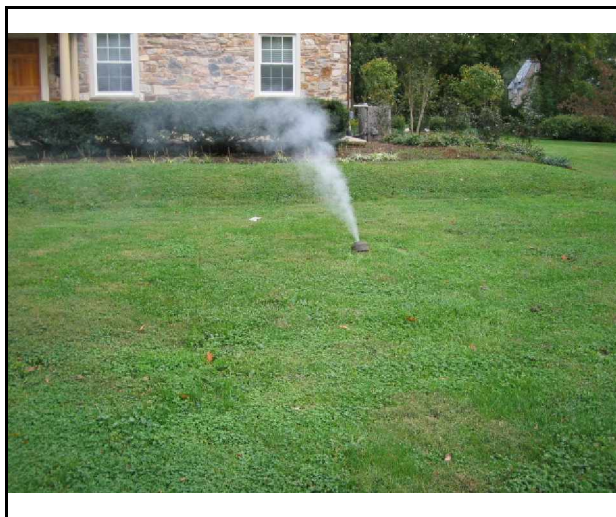
Unique Test ID	287	Date:	10/13/2004	MeterBasin:	01_WR29
Observer ID:	A	Crew:	T-3	Dye Test Recommended:	N
Defect No:	1	Setup No:	6	Priority CCTV:

House Number	3507	Street Prefix:		Street Name:	Bonfield	Street Type:	ROAD
Source Type:	04= Cleanout	Location:	7=Yard-Front	Severity:	4=Major		
Sector:	2=Private	Drainage Area:	0				
Comments:

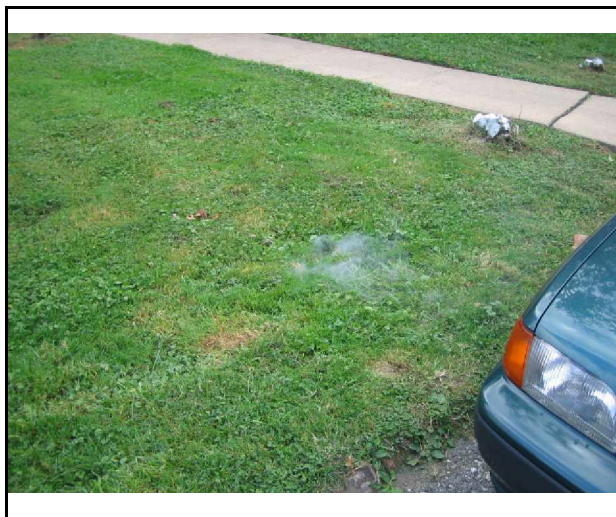
Unique Test ID	287	Date:	10/13/2004	MeterBasin:	01_WR29
Observer ID:	A	Crew:	T-3	Dye Test Recommended:	N
Defect No:	2	Setup No:	6	Priority CCTV:

House Number	3503	Street Prefix:		Street Name:	Bonfield	Street Type:	ROAD
Source Type:	04= Cleanout	Location:	7=Yard-Front	Severity:	2=Trace		
Sector:	2=Private	Drainage Area:	40				
Comments:

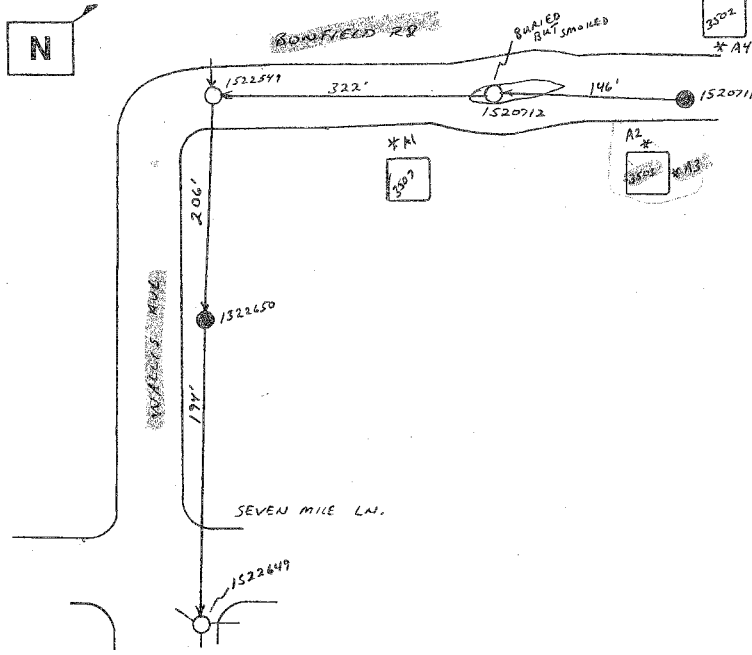
287

TEST LOCATION			
Project: WRPA	Sewershed: Jones Falls	Date: 10-13-05	Start Time: 1610
Crew: T3	Street Location: BONFIELD RD + WALLIS AVE		
US MH: 1520711	DS MH: 1522649	Number of Segments: 4	Test Length: 948'
Plugged US: Y <u>N</u>	Plugged DS: Y <u>N</u>	# of Blowers: <u>(2) 3</u>	Ground: <u>Dry</u> Moderate Wet
Plugs Removed? Y <u>N</u>	Recorder: <i>[Signature]</i>	Comments: 1520712 IS BURIED, BUT STILL SMOKE.

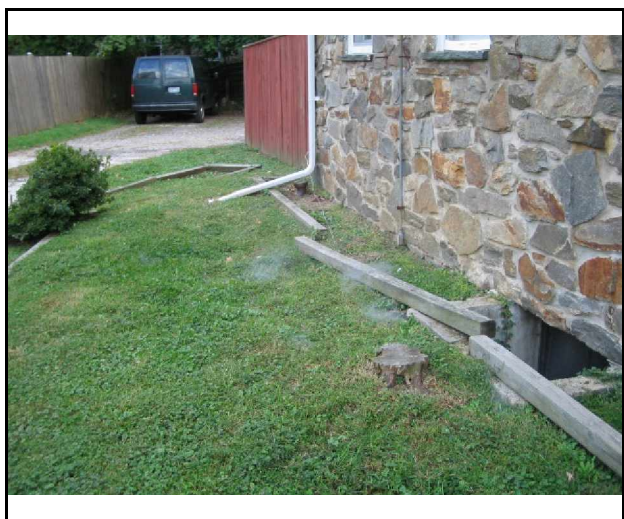
Unique Test ID	287	Date:	10/13/2004	MeterBasin:	01_WR29
Observer ID:	A	Crew:	T-3	Dye Test Recommended:	Y
Defect No:	3	Setup No:	6	Priority CCTV:

Source Type:	10= Foundation Drai	Location:	9=Yard-Side	Severity:	2=Trace
Sector:	2=Private	Drainage Area:	50

Comments: further evaluation is necessary to determine "Source Type"

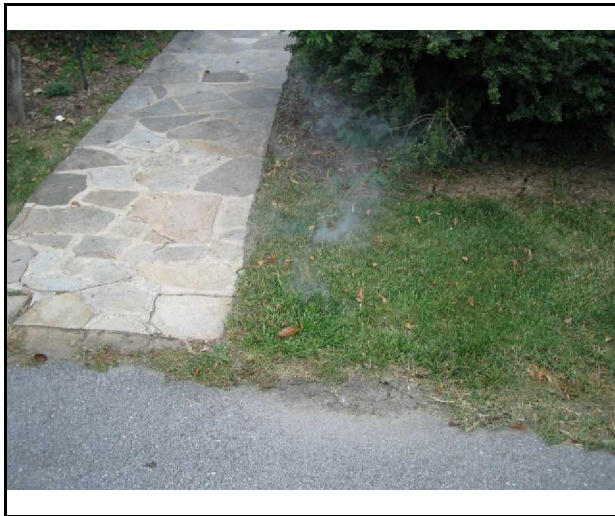
Unique Test ID	287	Date:	10/13/2004	MeterBasin:	01_WR29
Observer ID:	A	Crew:	T-3	Dye Test Recommended:	N
Defect No:	4	Setup No:	6	Priority CCTV:

House Number	3502	Street Prefix:		Street Name:	Bonfield	Street Type:	ROAD
Source Type:	02= Service Line	Location:	7=Yard-Front	Severity:	2=Trace		
Sector:	2=Private	Drainage Area:	50				
Comments:

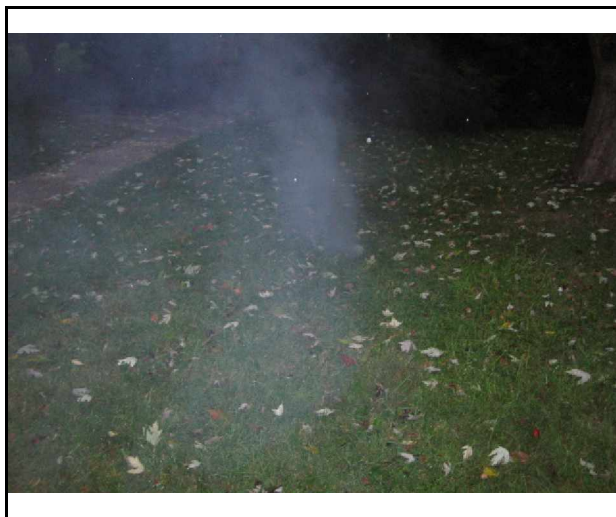
Unique Test ID	289	Date:	10/13/2004	MeterBasin:	01_WR29
Observer ID:	A	Crew:	T-3	Dye Test Recommended:	N
Defect No:	1	Setup No:	7	Priority CCTV:

House Number	Street Prefix:	Street Name:	Street Type:		
7037		Wallis	AVE		
Source Type:	04= Cleanout	Location:	7=Yard-Front	Severity:	4=Major
Sector:	2=Private	Drainage Area:	0		
Comments:

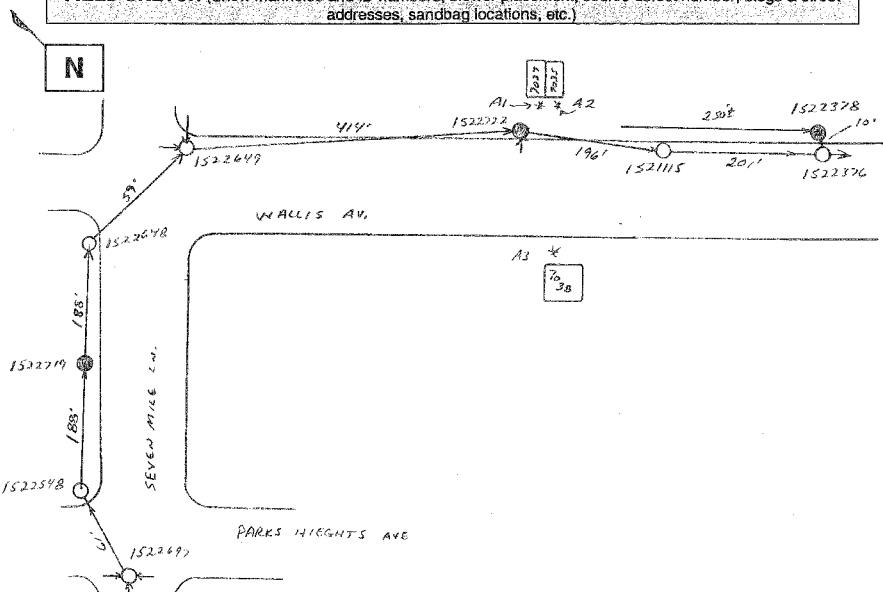
TEST LOCATION			
Project: WRPA	Sewershed: Jones Falls	Date: 10-13-04	Start Time: 1716
Crew: T3	Street Location: SEVEN MILE LN & WALLIS AVE		
US MH: 1522697	DS MH: 1522376	Number of Segments: 9	Test Length: 1567'
Plugged US: <input checked="" type="checkbox"/> Y <input type="checkbox"/> N	Plugged DS: <input checked="" type="checkbox"/> Y <input type="checkbox"/> N	# of Blowers: 1 2 3	Ground: <input checked="" type="checkbox"/> Dry <input type="checkbox"/> Moderate <input type="checkbox"/> Wet
Plugs Removed? <input type="checkbox"/> Y <input checked="" type="checkbox"/> N	Recorder: JAM	Comments:

TOO LG TO PLUG.

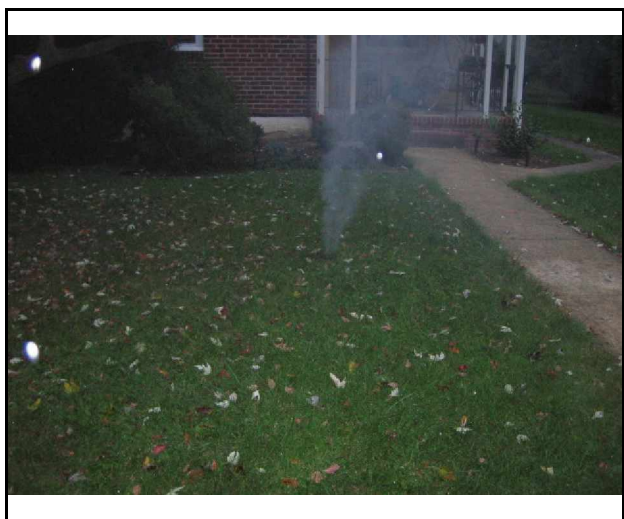
Unique Test ID	289	Date:	10/13/2004	MeterBasin:	01_WR29
Observer ID:	A	Crew:	T-3	Dye Test Recommended:	N
Defect No:	2	Setup No:	7	Priority CCTV:

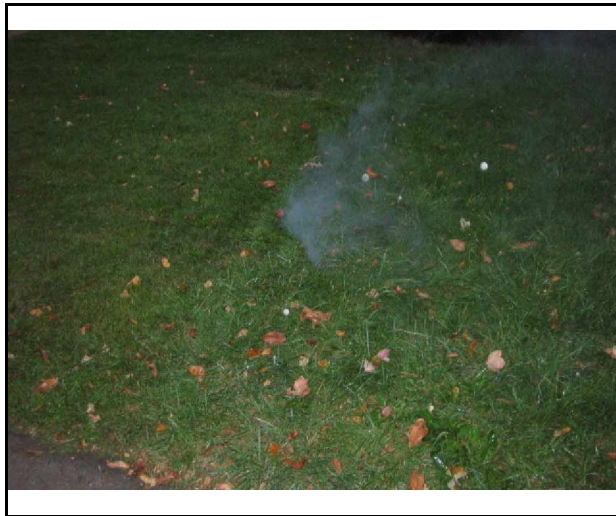
Unique Test ID	289	Date:	10/13/2004	MeterBasin:	01_WR29
Observer ID:	A	Crew:	T-3	Dye Test Recommended:	N
Defect No:	3	Setup No:	7	Priority CCTV:

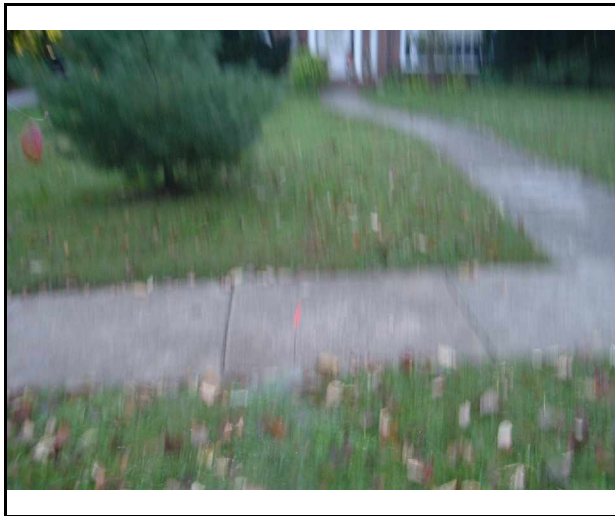
Unique Test ID	290	Date:	10/18/2004	MeterBasin:	01_WR06
Observer ID:	A	Crew:	T-1	Dye Test Recommended:	N
Defect No:	2	Setup No:	1	Priority CCTV:

House Number	3207	Street Prefix:		Street Name:	Bancroft	Street Type:	ROAD
Source Type:	02= Service Line	Location:	5=Sidewalk	Severity:	3=Moderate		
Sector:	1=Public	Drainage Area:	75				
Comments:

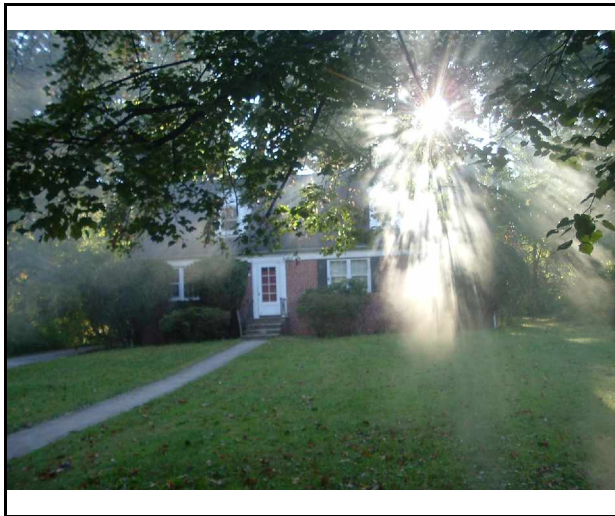
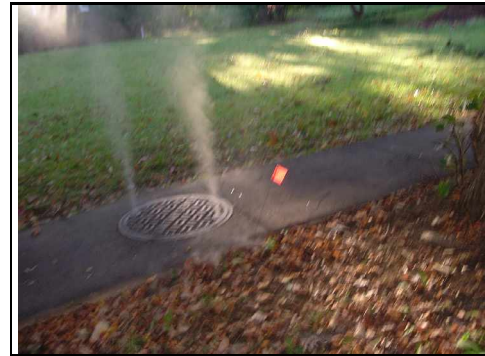
Unique Test ID	290	Date:	10/18/2004	MeterBasin:	01_WR06
Observer ID:	A	Crew:	T-1	Dye Test Recommended:	N
Defect No:	3	Setup No:	1	Priority CCTV:

Comments: Probably from MH
